ARRI TECHNICAL NOTE P - 1019

ARRIMAG 300E "Not Ready" August 1, 2000

Summary

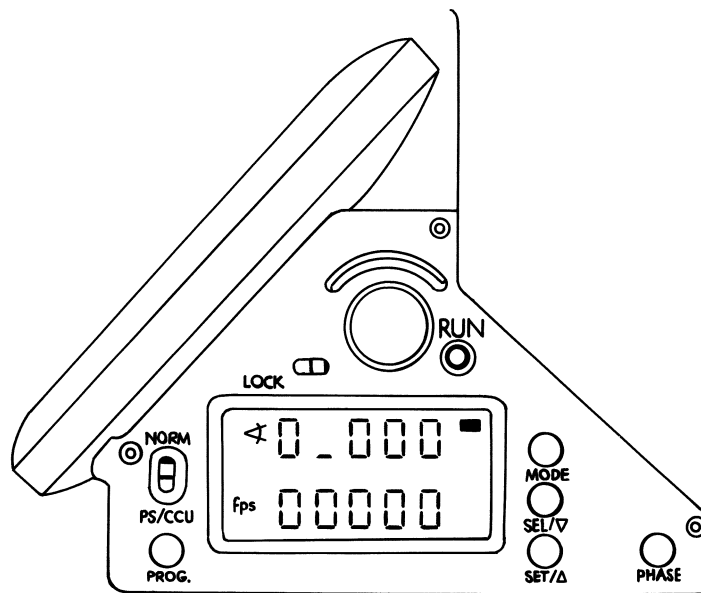
If a problem with the ARRIMAG 300E (the torque motor driven 1000' magazine for the 435) prevents the 435 from running, the camera's RUN LED will glow red, and the second digit on the top line of the display will turn into an underline (see graphic). This is the "ARRIMAG 300E Not Ready" status, which could be caused by one of the following 5 conditions.
